SZOKOLYA KÖZSÉG VILLÁMÁRVIZEI

FLASH FLOODS IN THE SETTLEMENT OF SZOKOLYA

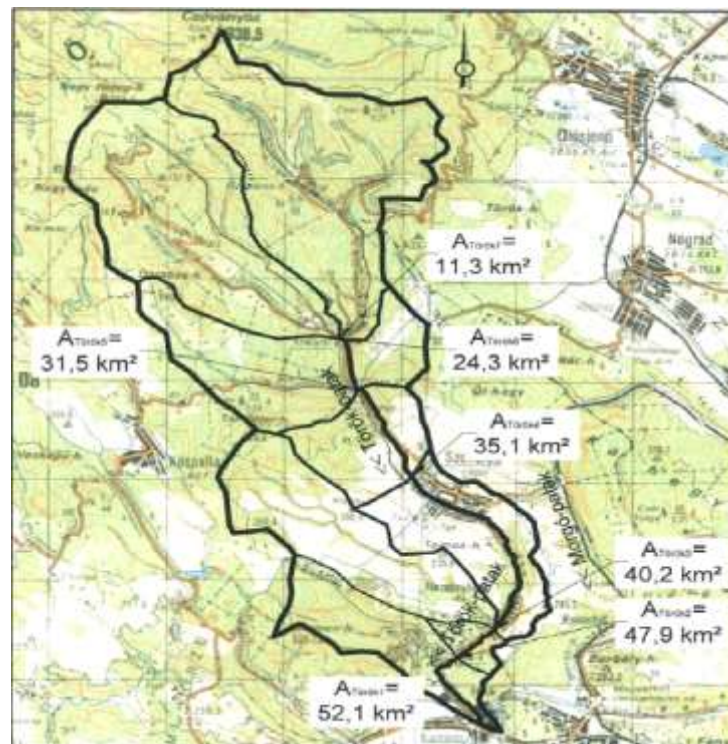
The area layout plan of Stream Török; the delineation subcatchments within the river basin district (source: the planning permission of the “Riverbed regulation of Stream Török” issued by the Vizimű Bt. Reference number: VM-06/01)

Stream Török in the settlement of Szokolya is situated in the northern part of Mid-Hungary, between Kismaros and Királyrét. It is the right-hand side branch of Stream Morgó that belongs to the left-bank water catchment area of River Danube. This fast flowing stream threatens the settlements of Szokolya, Kismaros and Verőce partially with flooding, which are located on the southern region of Börzsöny Hill. [1] The valley floor, which is of varied width along both sides of the riverbed, has been heavily urbanised in the past few decades. The newly-built estates are mostly bungalows and weekend houses, although many are often used for permanent habitation. To channel the flash flood on the stream, there remained only the winding mean water level riverbed, occasionally densely covered by lush flora. As a result of the reduced area of the flood plain, water levels have risen a great deal since 1999. The flooding on the stream wreaked considerable havoc on the settlement of Szokolya numerous times: twice in year 2010, and subsequently in 2014 and 2016.

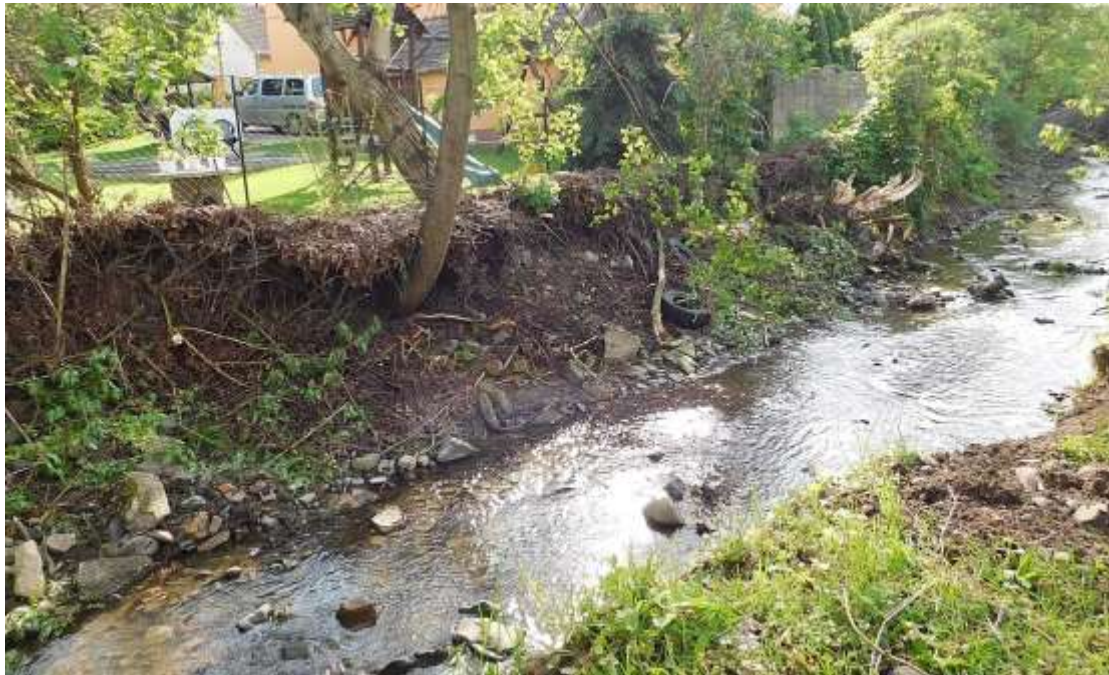
Riverbank destruction (photo taken by Berkes Róbertné)

The destruction reached not only private estates, but also bridges for transportation, public utilities, the riverbank itself and its water protection facilities. In order to reconstruct the original conditions, the local council of Szokolya submitted a so-called ‘vis maior’ competition to deal with the damage done in 2010. From the support won in the competition, the reconstruction of the riverbank was carried out alongside the river in a few stages, in the stretch of 3188 metres altogether, restoring the canal embankment with scattered rocks and gravel.

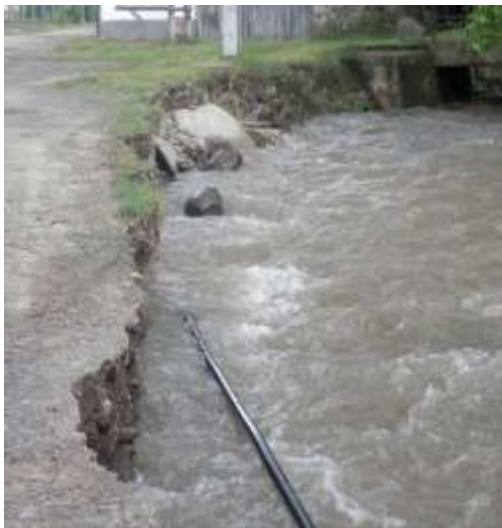
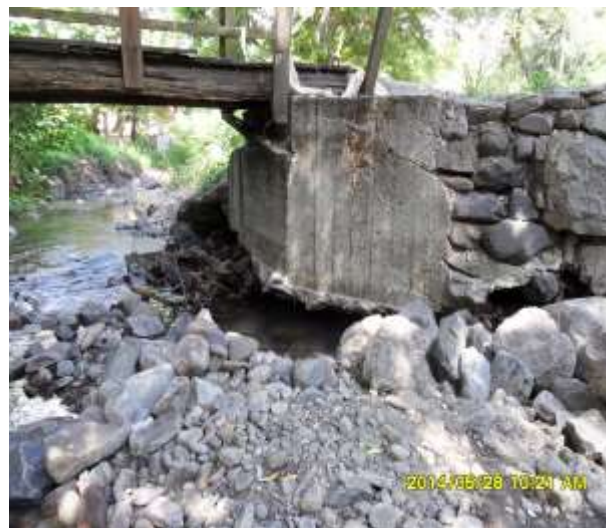
Further damage (photo taken by the author)

An intensive downpour on 17 May 2014, caused massive flooding on the stream. The flowing water destroyed much of the streambed and the stream bank, posing serious threat to flood retention facilities, roads and public utilities. The flow defected the stone cladding that had

been built prior to the flooding, threatening to undermine it, and the embankment, thereby putting nearby estates at major risk. To utilise government subsidy, the local council submitted a competition. Under the auspices of the ‘vis maior’ process, the authorities inspected the scene on 26 May 2014. During the inspection, 13 scenes of destruction were designated which were to undergo reconstruction and preventive measures. Most of the destruction had already been recovered in 2010, however, the scenes were affected anew in 2014.

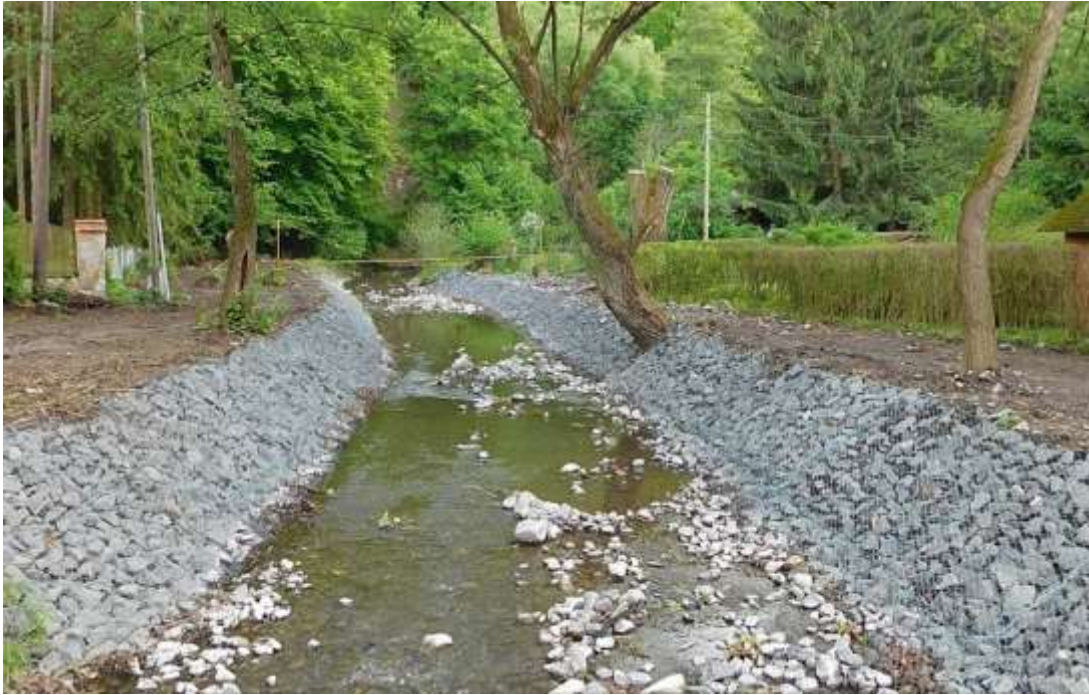
Reconstruction, photo taken by Berkes Róbertné

Gabions are steel wire cages filled up by stones on the premises, facilitating stability for the embankment through their weight, whereas gabion RENO mattresses are of shorter height, and are primarily constructed to provide a solid riverbed for the water course. Gabion structures are fast and economical to build in all circumstances, and are especially suitable for stabilising the embankment in hilly regions and areas of low soil quality. Gabion bulkheads are flexible; soil movements, however, do not influence the load bearing capacity of already functioning retaining wall structures. Vegetation will settle on gabion bulkheads within 1-2 years, nonetheless, selected plant species may be grown on them, too. [3]

A different reconstruction method, being employed gradually since 2010, guaranteed that the flash floods of February and March 2016 did not damage those riverbed phases which had been rebuilt after the events in 2014, and proved to be functioning properly. The flexible gabion structure, soon blending with nature, safeguarded the stability of the embankment and further protection against water destruction. Good samples are worth copying: many more Hungarian settlements which are under threat of flash floods (Tahitótfalu, Kismaros, Solymár) have used this method, or are considering the alternative solution of gabion cages.
