Strategy or disaster: New-style river regulation as an issue of national security

Abstract

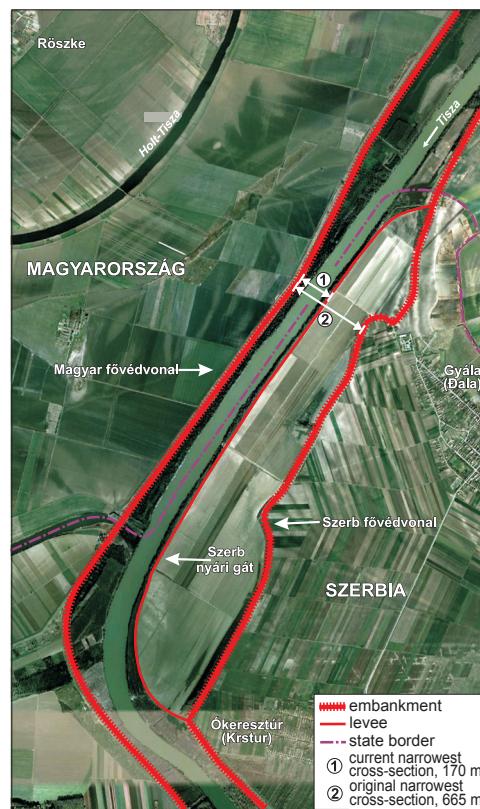
Fig 5. Shrinkage of active floodplain of Tisza in Serbia due to the construction of levees (eds: NAGY, I. and SCHWEITZER, F. 2011 by using Google Earth images)

Sedimentation in active floodplains is considerable and will lead higher and higher flood levels in the future, as it can be seen on the example of the Tisza, Danube or Körös rivers. A new flood-control concept is also necessary for the Danube which would employ new approaches to flood-level reduction (e.g. floodway reconstruction, water diversion, storage and others) and the raising of the design height of dykes only where the previous techniques remained unsuccessful. In many places of the floodways of large rivers it is visible that the zones where floods are conveyed unhindered are significantly reduced through groynes, higher summer dykes (levees), forestation or housing development (Figure 5).
